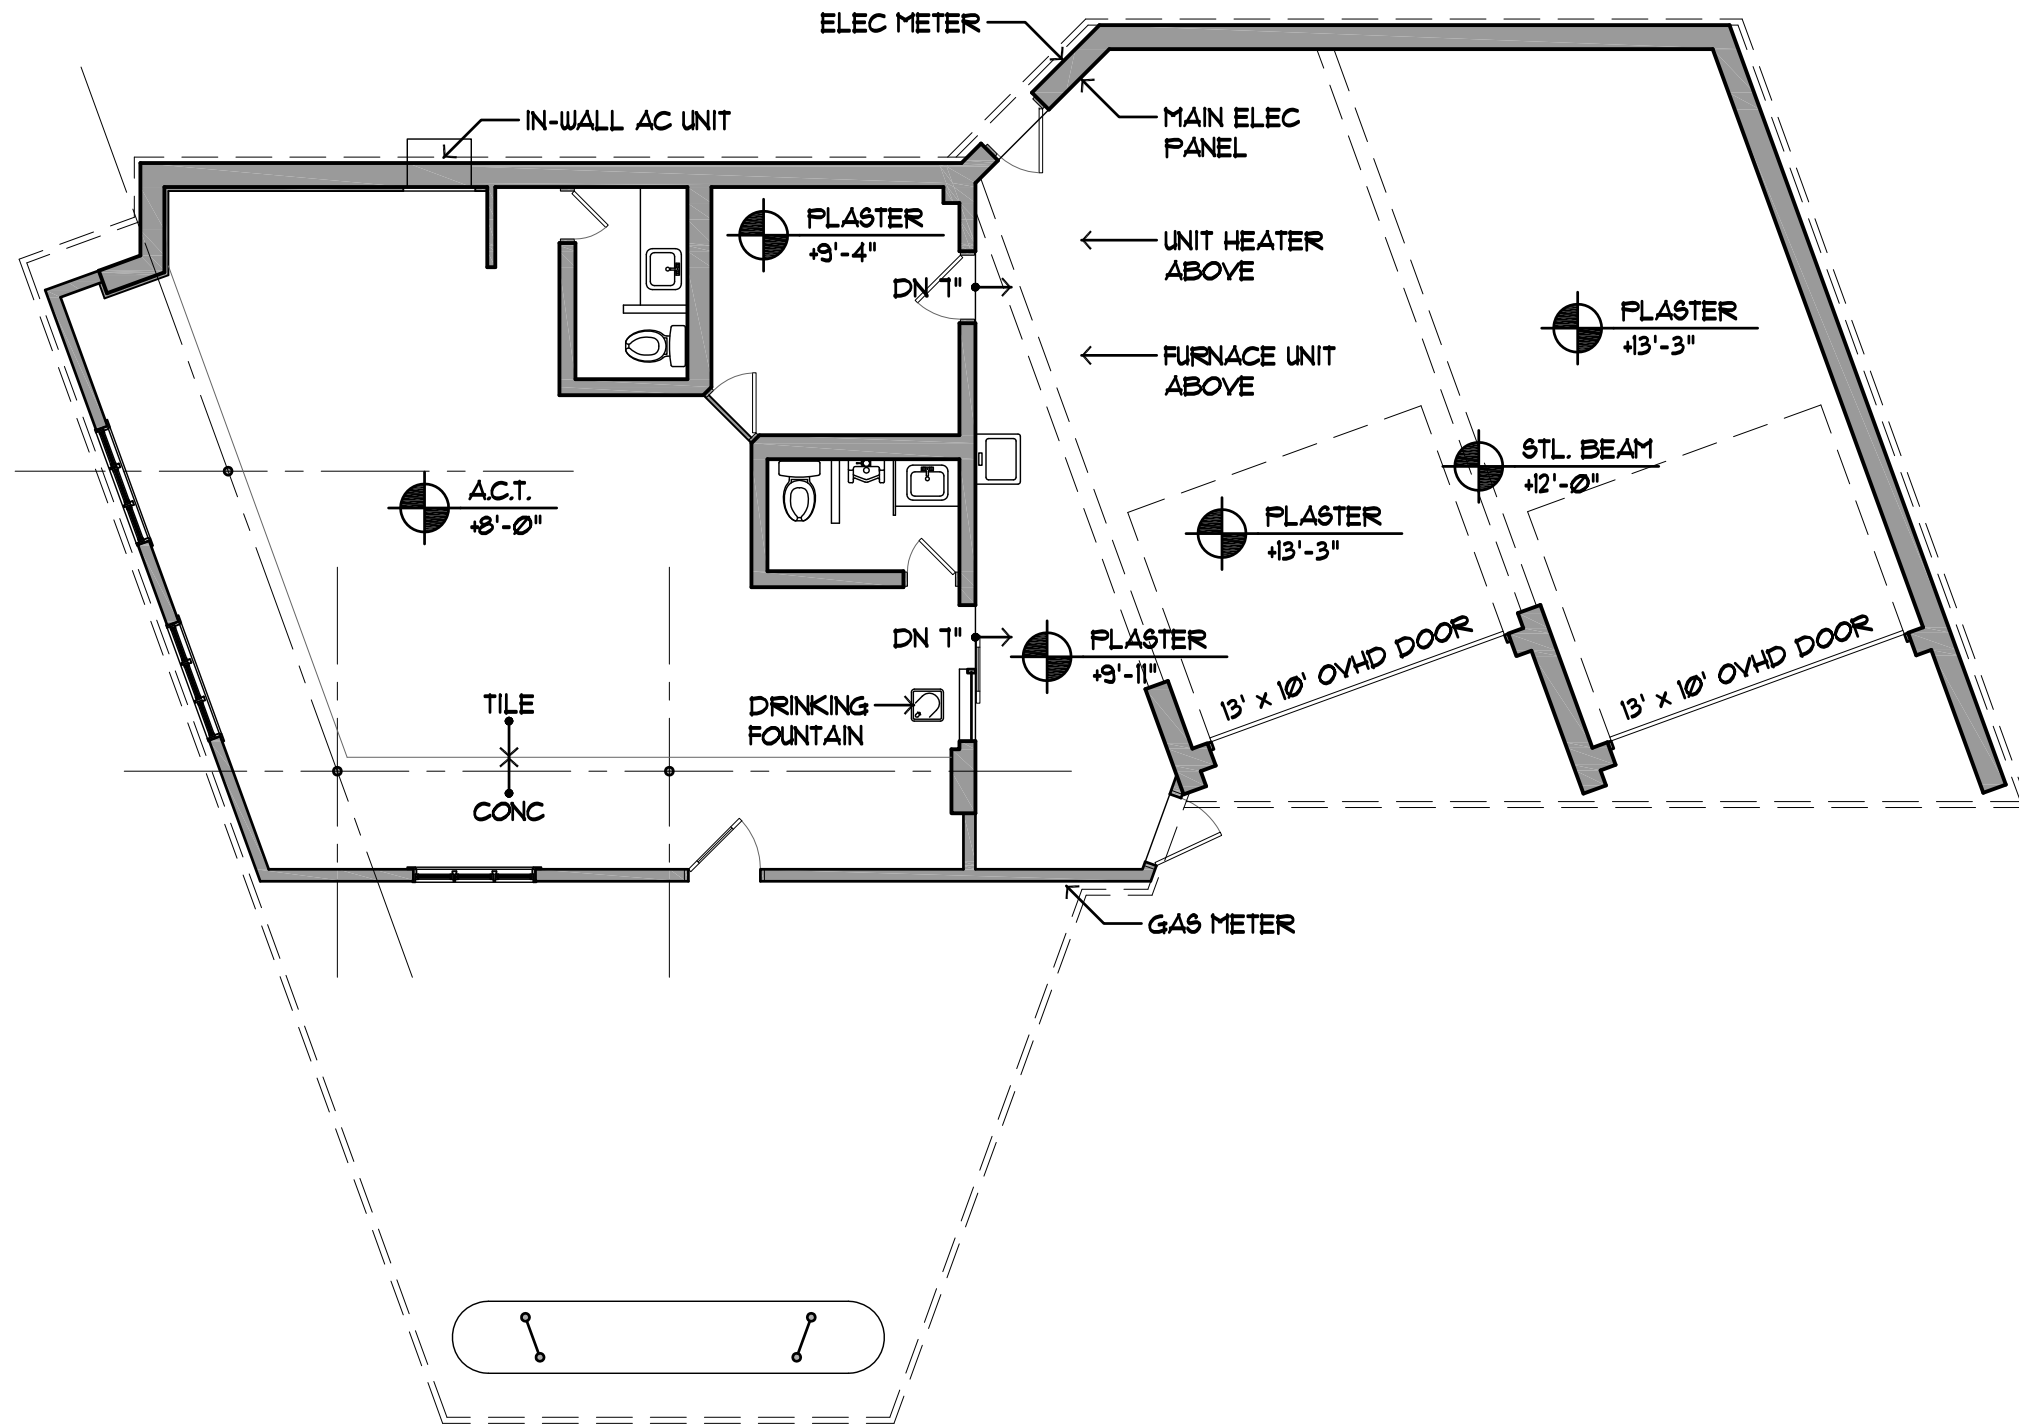
1. ROOF ABOVE SHOP AREA SHOWED MANY SIGNS OF CURRENT AND PAST LEAKAGE.
2. PLASTER CEILING IN SHOP AREA HAS EXTENSIVE WATER DAMAGE.
3. CEILING MATERIALS AND HEIGHTS AS NOTED ON PLAN.
